# **The Immediate Implant with Immediate Provisionalization Non Occlusal Loading**

## **The Immediate Smile Procedure- Single Tooth Application**

**Drs. Alan Rosenfeld and George Mandelarlis**  
Diplomates, American Board of Periodontology

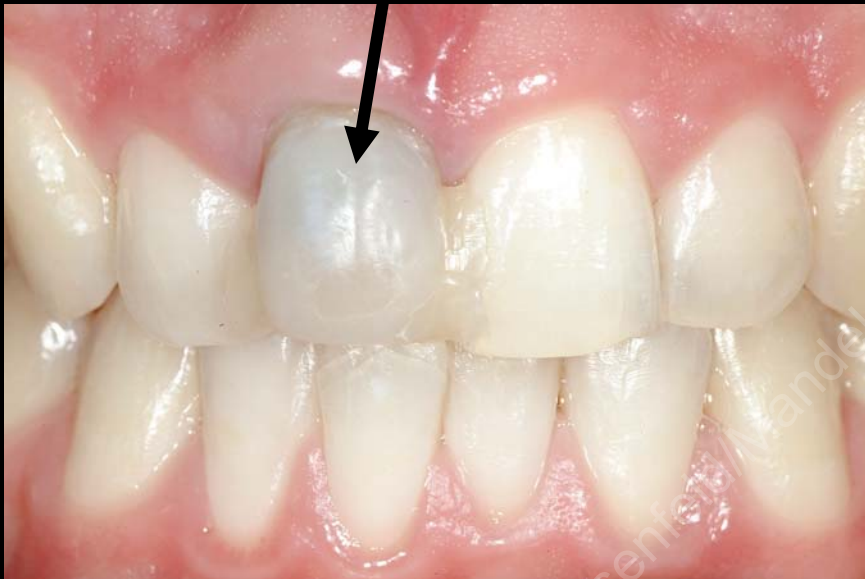
Fractured tooth #8

- A 20 year old male suffered a skateboarding accident at college and fractured his front tooth (maxillary right central incisor- #8). This tooth was deemed not restorable by his general dentist because the fracture was too far below the gum line and tooth much tooth structure had been lost as a result of the fracture.
- This picture shows the tooth re-bonded temporarily after the accident

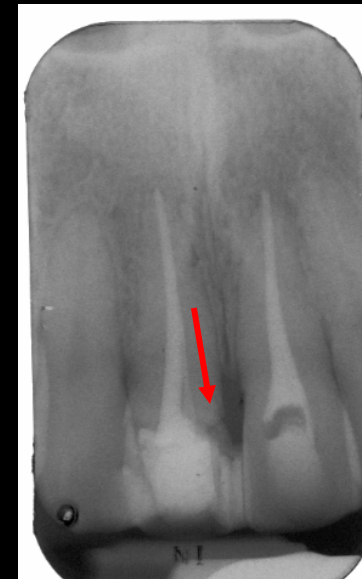
Fractured tooth #8

- Initial X-ray with tooth re-bonded. Tooth #8 is not restorable as a result of a fracture (red arrow) secondary to trauma, while tooth #9 is savable.

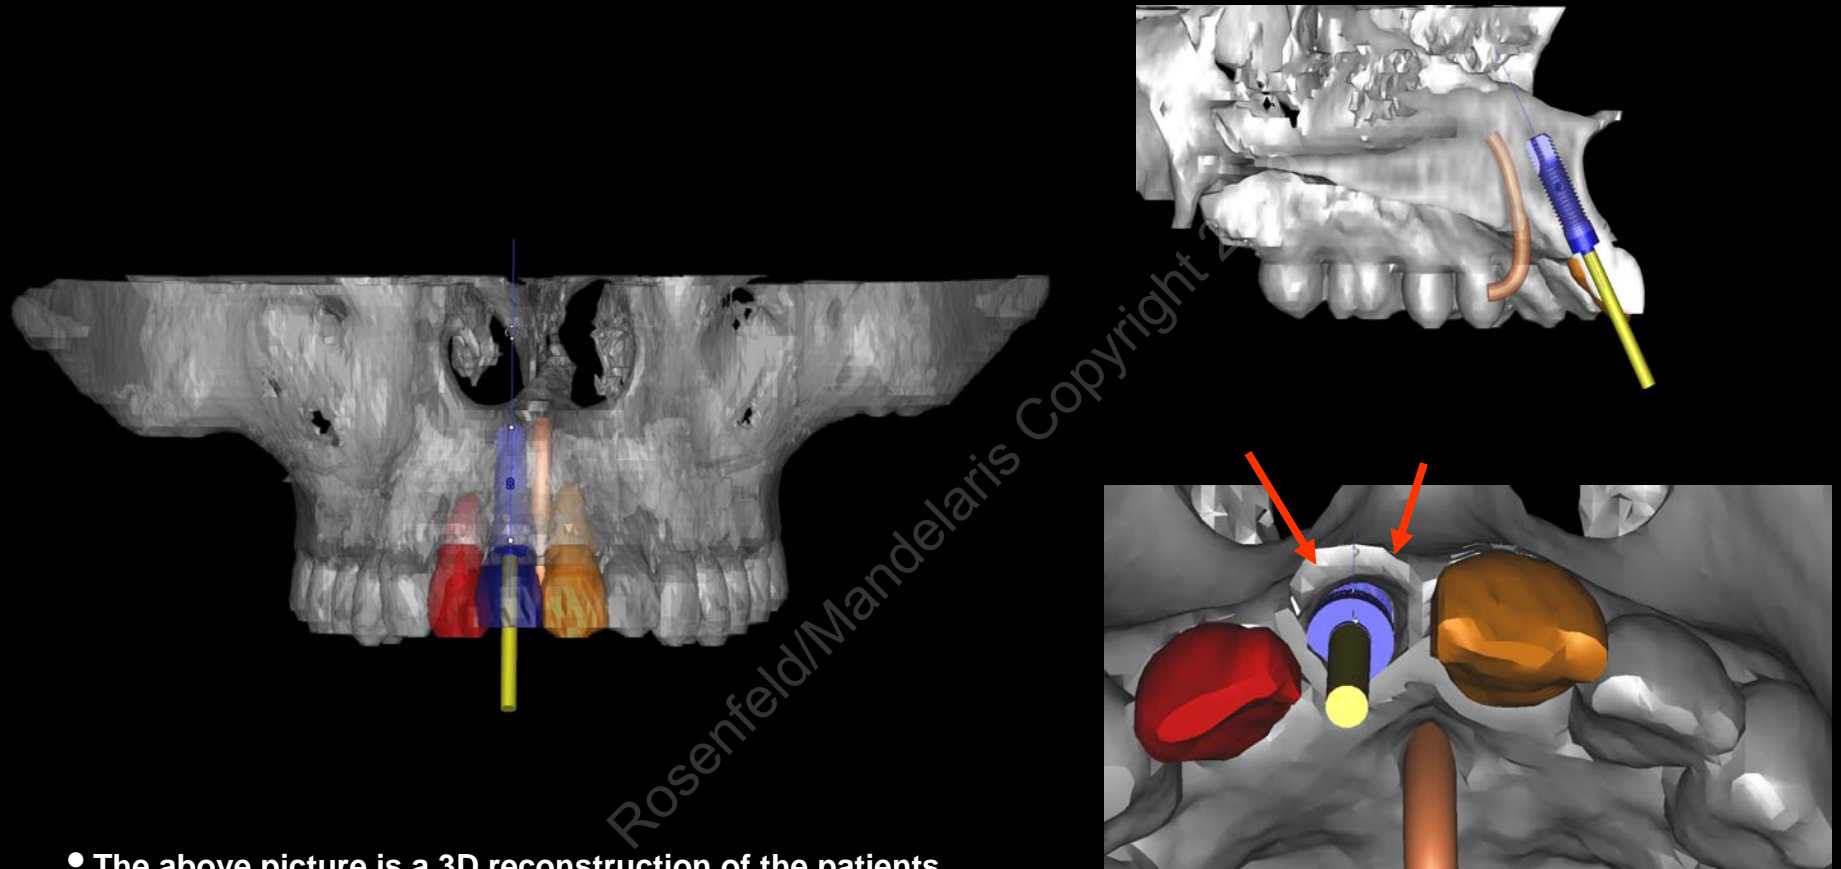
# CT scan diagnostic treatment planning

- The above picture is a 3D reconstruction of the patients upper jawbone demonstrating the planned position of the implant after tooth extraction. The adjacent teeth are in differing colors so that their roots can be seen and protected. The nerve is also colored in orange so that it is not violated.

- These two images show the cross sectional view (top) of the precise position of the jaw bone where the implant will go so that we can be certain that the patient has enough bone width to accommodate implant placement BEFORE the actual surgery. The bottom image shows the tooth socket:implant “gap” that will occur, necessitating a bone graft be performed to fill the void.

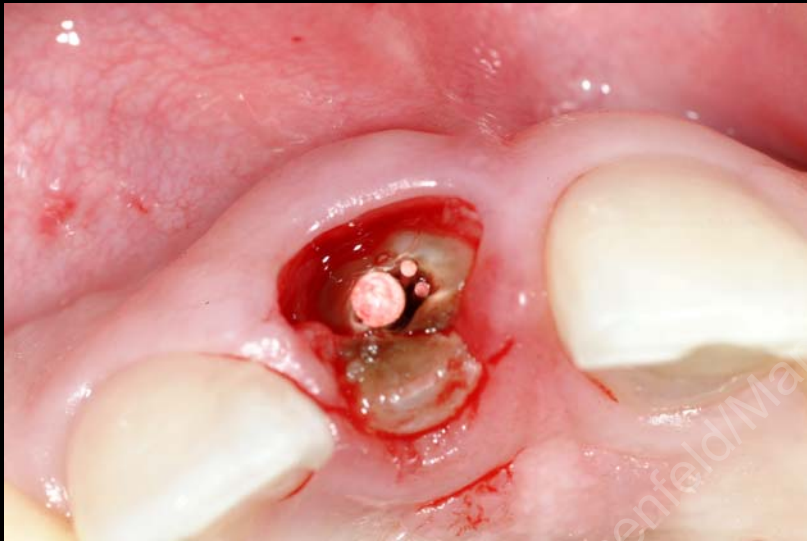
Pre Op

**Fractured, non restorable #8**

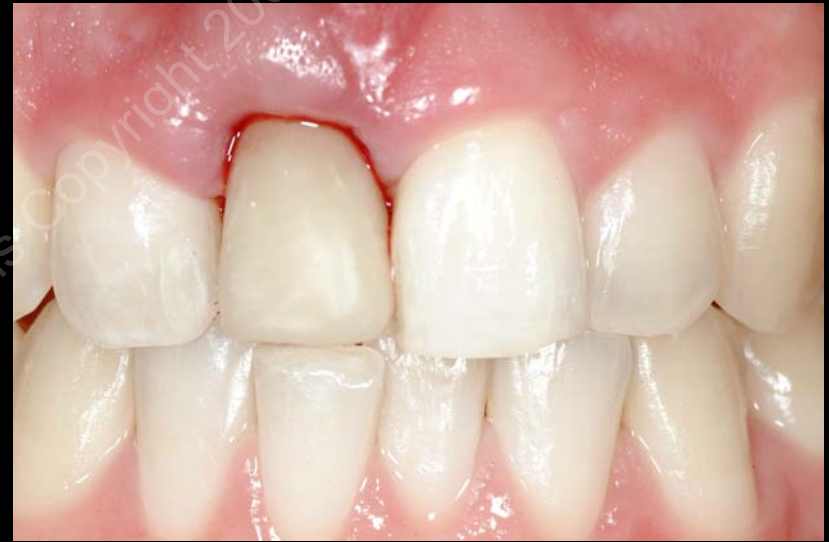
Post Op

After tooth extraction, immediate implant placement and immediate provisionalization. These events occurred on the same day and were carefully planned in a collaborative fashion with the patient's dentist to ensure a predictable result. No stitches were used because the gum did not need to be opened for this procedure to occur. These decisions were made ahead of time, largely as a result of having a CT available to study the patients anatomy before surgery occurred.

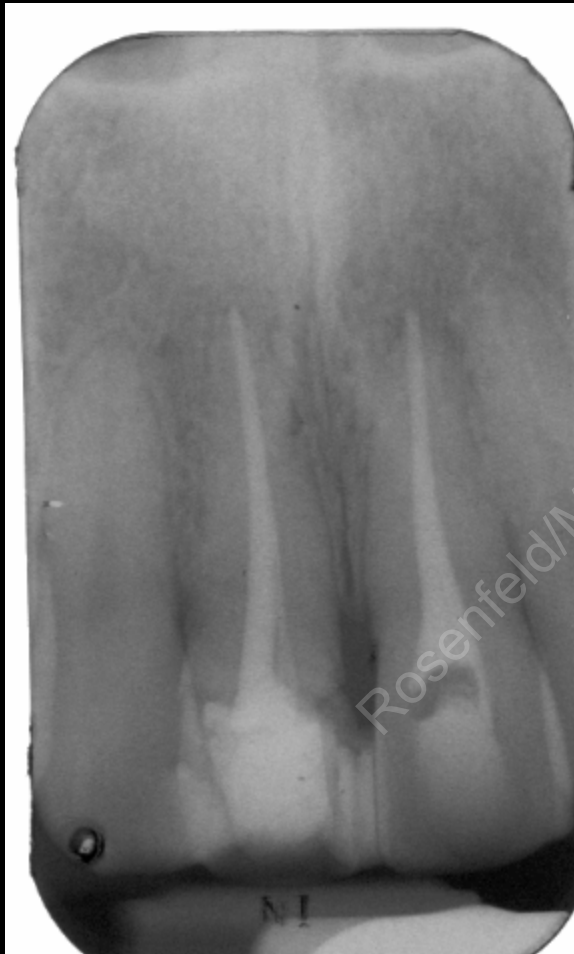
**BEFORE**

- Initial X-ray with tooth re-bonded. Tooth #8 is not restorable while tooth #9 is savable.

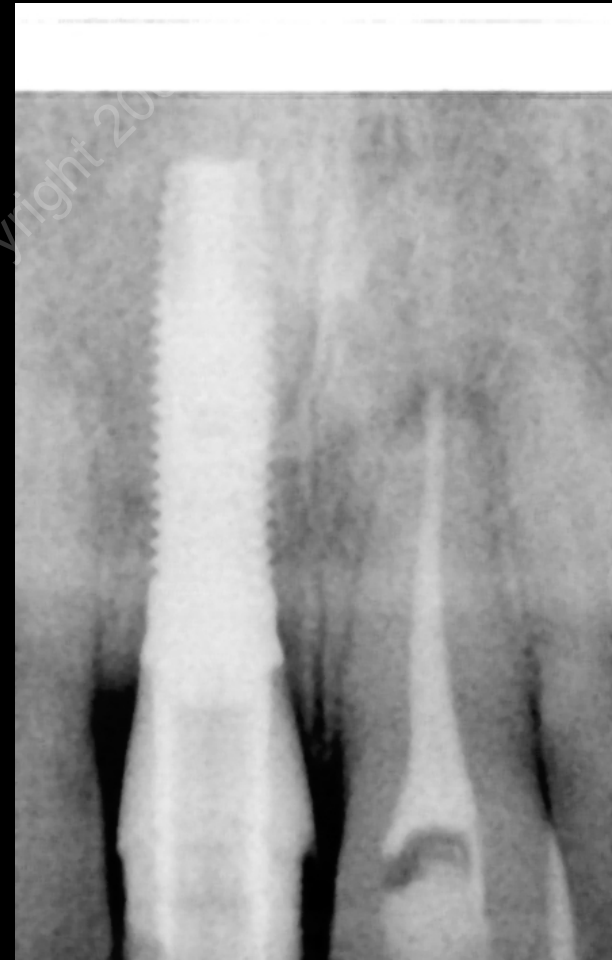
**AFTER**

**Immediate implant + immediate non occlusal load provisional #8**

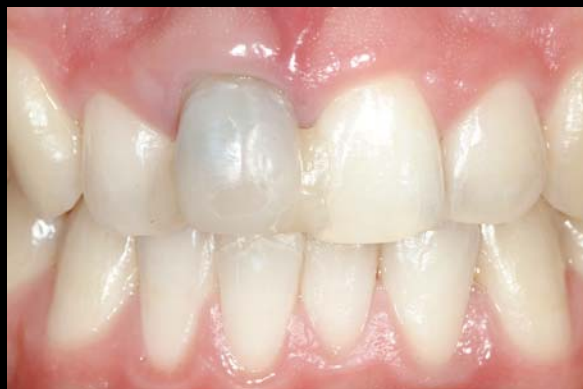
**Initial Presentation**

**Tooth #8 is fractured**

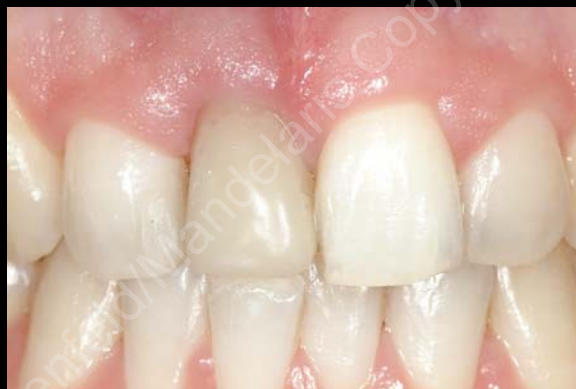
**Immediate Provisional**

**Temporary tooth is placed on implant the same day as surgery occurred.**

**Note that the gum line has not changed. This helps ensure the esthetic result will be natural and pleasing.**

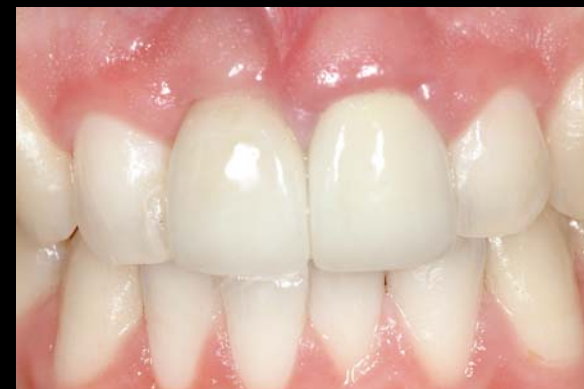
**Final Tooth**

**This is the final porcelain crown on the implant as well as for #9.**

**This result is shown at 2 years after it was finalized to emphasize the long-term nature of the result achieved.**
